TECHNICAL INSPECTION REPORT

⑥ OPERATION CROSSROADS.

U.S.S. ARKANSAS (BB33).

TEST ABLE.

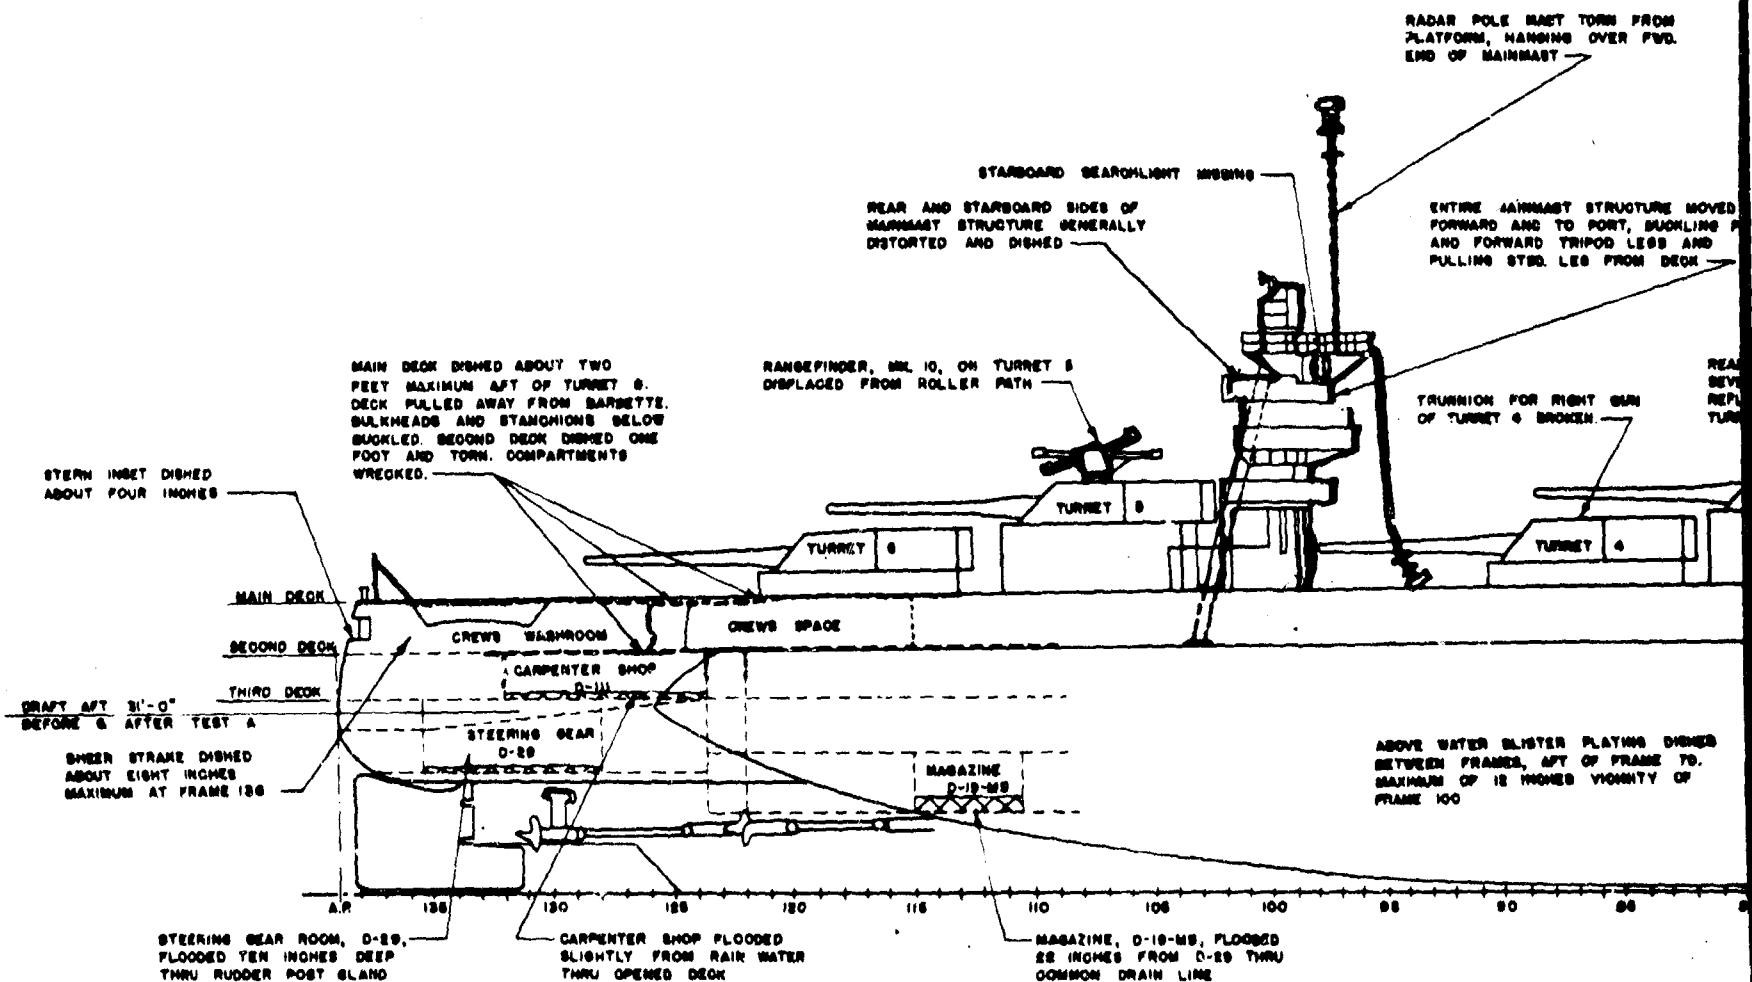
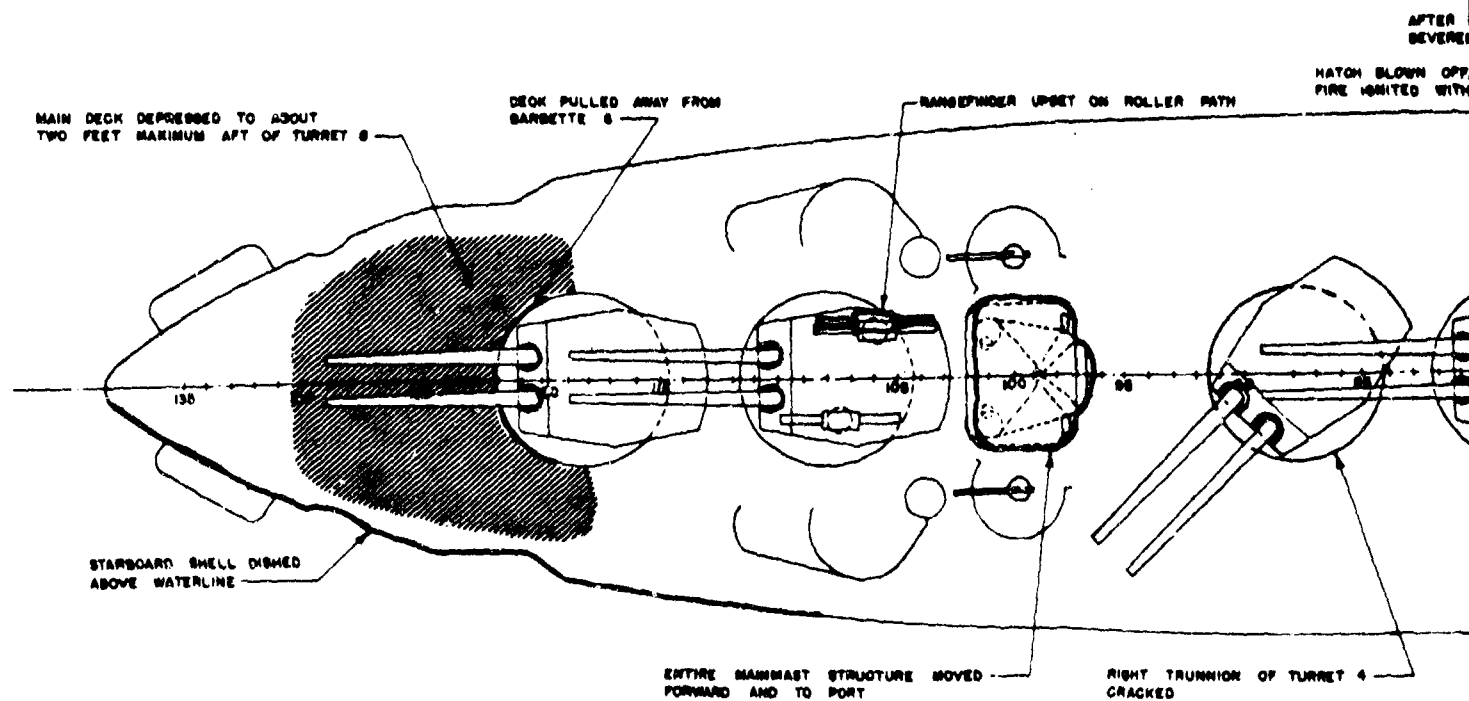
ADAR POLE PART TORN FROM
PLATFORM, HANGING OVER FWD.
END OF MAINMAST

'66" RADAR MAST COLLAPSED
TO PORT AND FORWARD

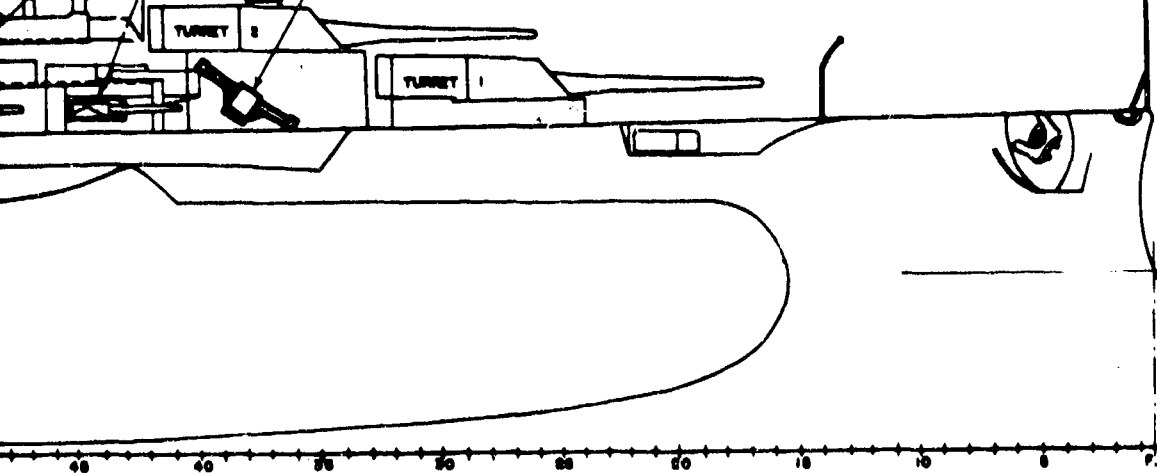
ARCADISTLE GUN PORT COVERS DAMAGED BY BLAST

RANGEFINDER, MK. 10, ON TURRET 2 BLOWN DOWN TO MAIN DECK, STARBOARD SIDE

SUPERSTRUCTURE DECK DAMAGED BY FIRE IN TEST EQUIPMENT

UPPER PORTION OF FORECAST DAMAGED BY BLAST

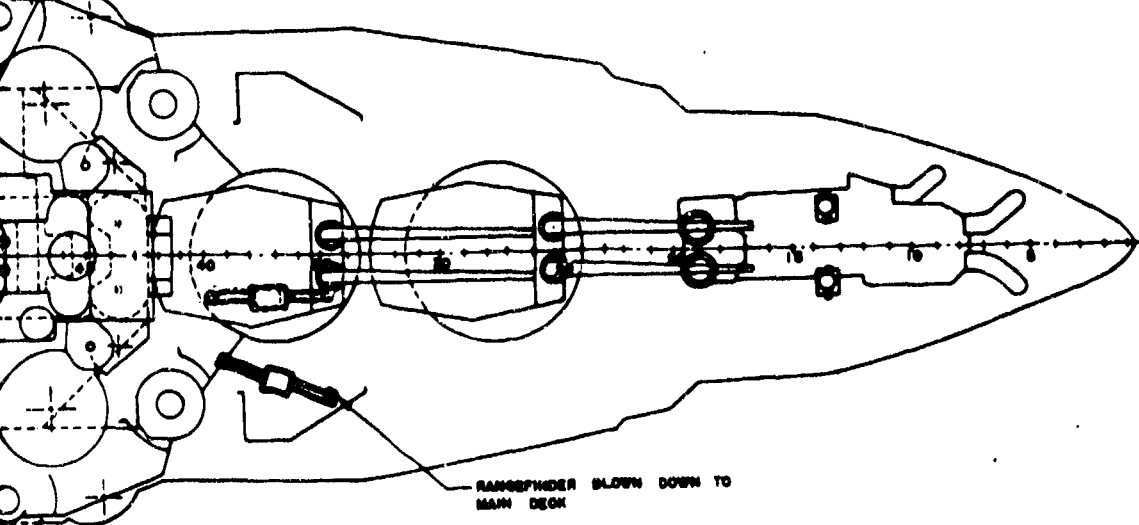
STRUCTURE DECK DAMAGED IN ARMY EQUIPMENT

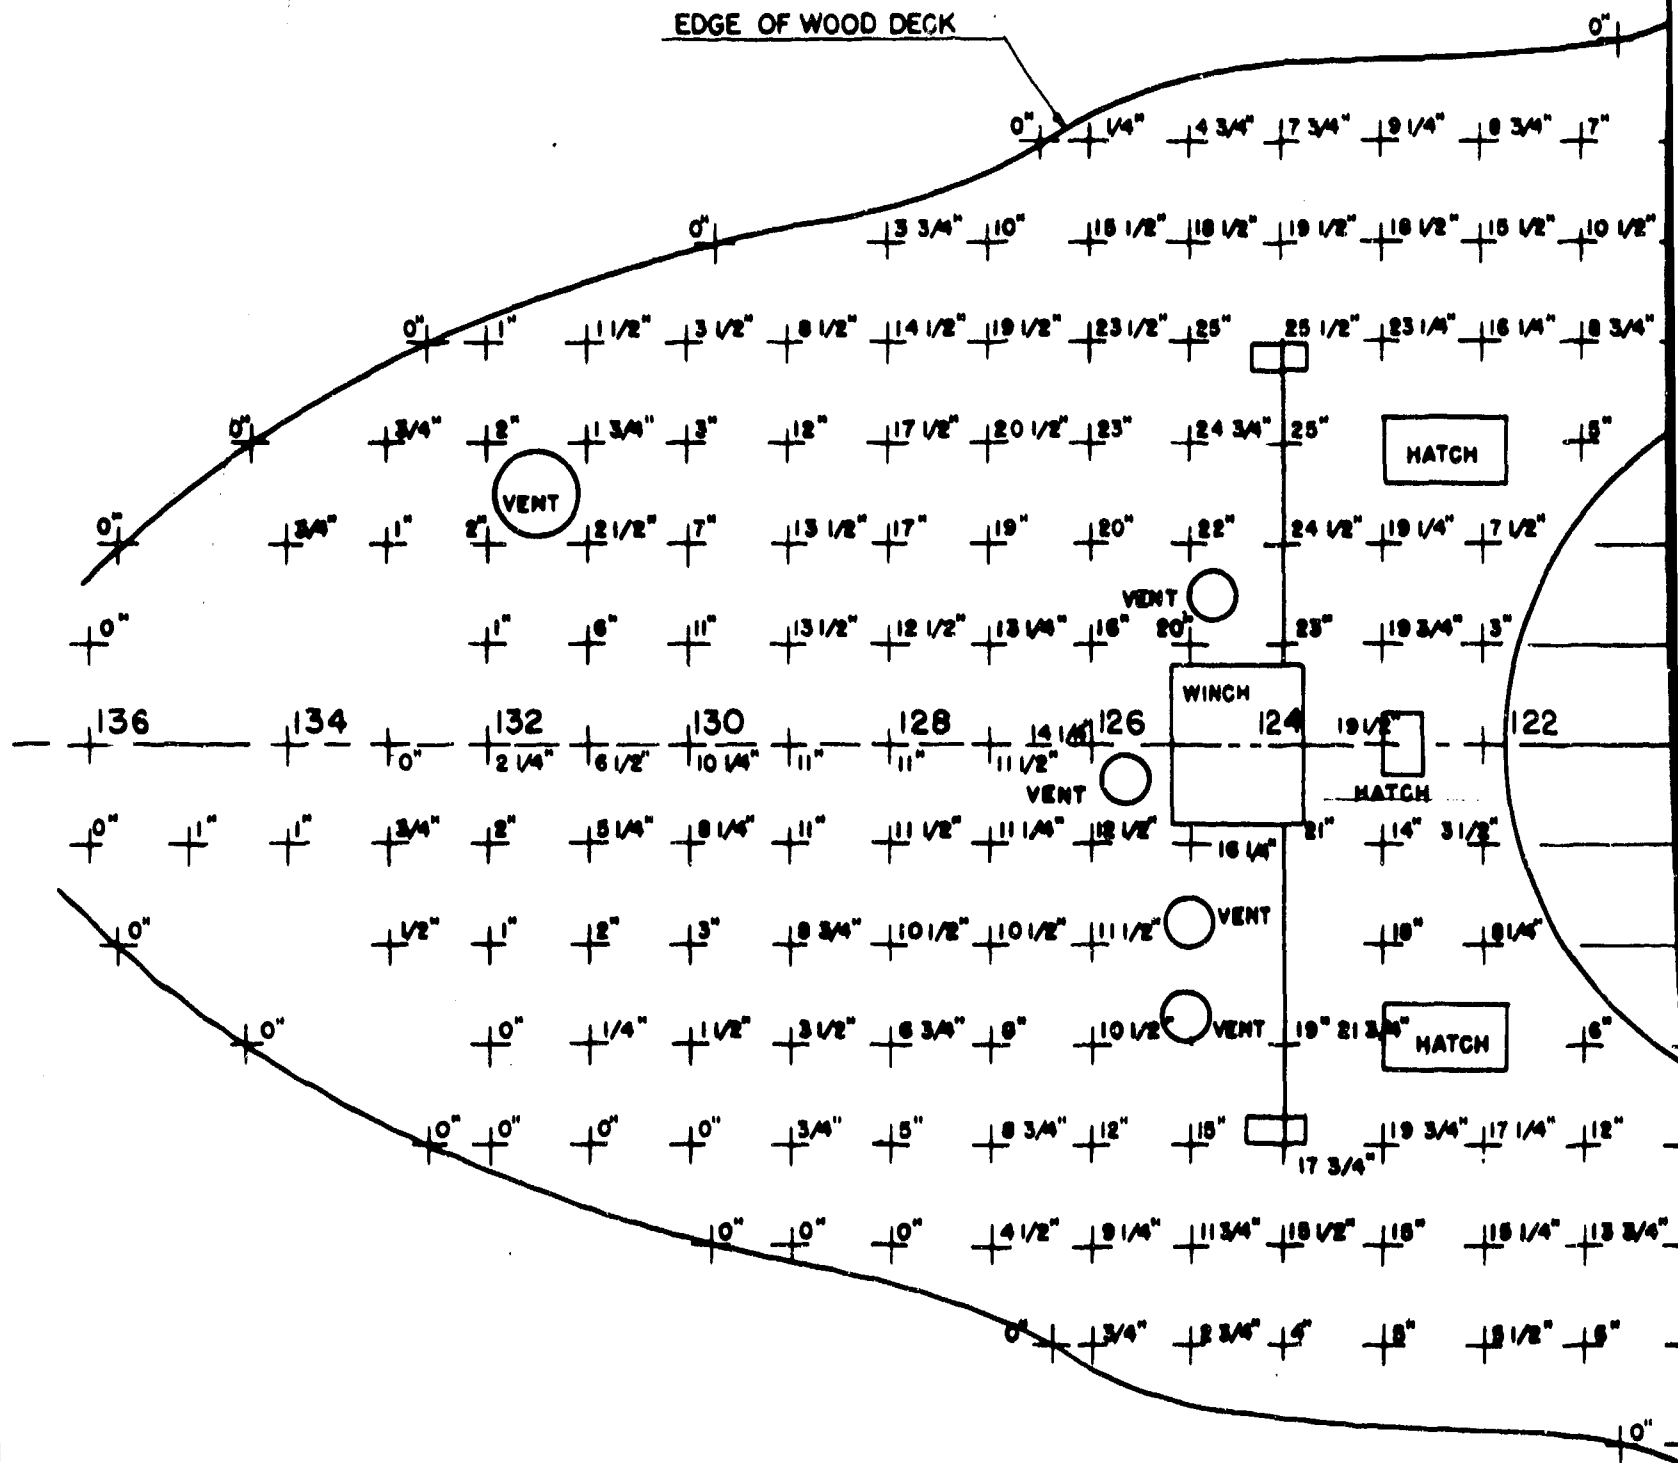
PLAN OF MAIN DECK

DEFLECTIONS WERE MEASURED FROM STRINGS STRETCHED LONGITUDINALLY ON THE DECK. ENDS OF THE STRING WERE EXTENDED TO PORTIONS OF THE DECK REASONABLY FREE OF ANY DEFLECTION. IN THIS RESPECT, IT WAS NECESSARY TO ASSUME THAT THE EDGE OF THE WOOD DECK ALONG THE SIDES WAS LEVEL WHICH IS UNTRUE. DISHING OF THE DECK CAUSED THIS EDGE TO PULL INBOARD AND DOWN. SEE SKETCH "A".
